Corrupted Fuel Consumption Reading on Rover SD1 Efi Cars

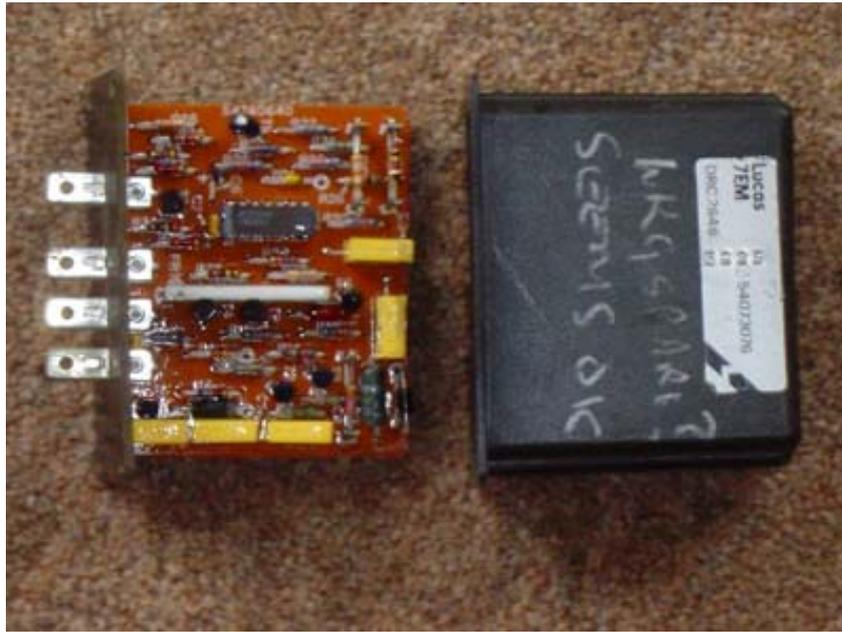
On Efi cars the normal (ex-carburettor) fuel flow meter signal to the trip computer is replaced or emulated by an interface unit (see above image) which calculates fuel usage using a signal derived from No 8 injector. Fuel usage, of course, is directly proportional to injector "open time", so electronic conversion was an obvious and accurate design solution.

The trip computer fuel flow interface is located behind the gauges in the instrument binnacle and I substituted it with a unit obtained at a Rover SD1 Club spares day. The problem immediately disappeared but after a few weeks the intermittent corruption mysteriously re-appeared.

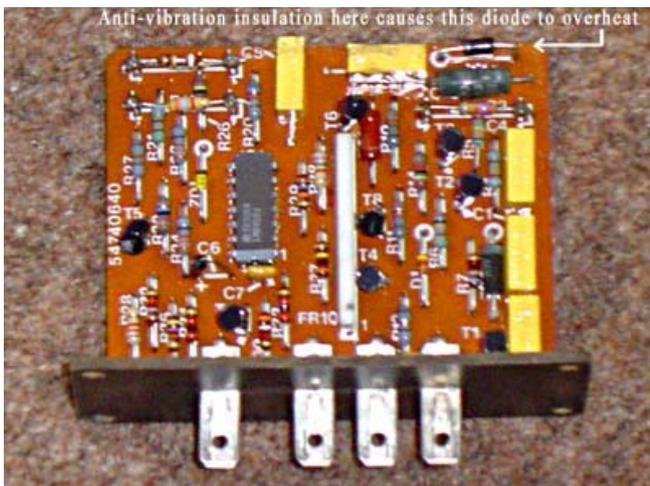
Next, I dismantled one of the units by drilling out the four rivets that secured the cover, exposing the internal printed circuit board for inspection. At the end of the board an anti-vibration foam pad glued to a large yellow capacitor also covered an adjacent diode that appeared to have overheated.

In doing so it had crystallised the adhesive, the foam and its own paint and markings leaving the diode effectively coated with carbonised junk. I cut away the offending foam, thoroughly cleaned up the diode, re-soldered all the local joints for good measure and reassembled the unit using screws in place of the rivets. Back in the car, the intermittent fault on that unit was cured.

I believe the component concerned is a Zener Diode, which is used as a reference voltage within the electronic circuitry. If true, this type of diode is known to be temperature sensitive.

On sunny days the interface location, below the windscreen, gets very hot and the combined effect of this hostile temperature and the foam pad trapping heat within the unit, with no means of cooling, causes the component to operate outside its temperature tolerance or even to fail completely. This might explain why some subsequent interfaces remained unrepairable using the above method.

- Replace the faulty diode with a higher rated device. (Without a circuit diagram or component list, I don't have a specification).
- Relocate the interface, perhaps below the fascia, but this would require a cable extension.
- Coat the diode with electrical heat sink gel/grease to further reduce the local overheating effect.
- Drill ventilation holes in the plastic cover adjacent to the diode.

So there you have it! If you own a Rover SD1 Efi car and have experienced intermittent low "Instant" mpg readings on the trip computer, as described, have a look at your fuel flow interface! My experience showed beyond doubt that the diode overheats and removing the anti-vibration insulating foam from the end of the board, cleaning up and resoldering the diode can cure the fault.
