Corrupted Fuel Consumption Reading on Rover SD1 Efi Cars

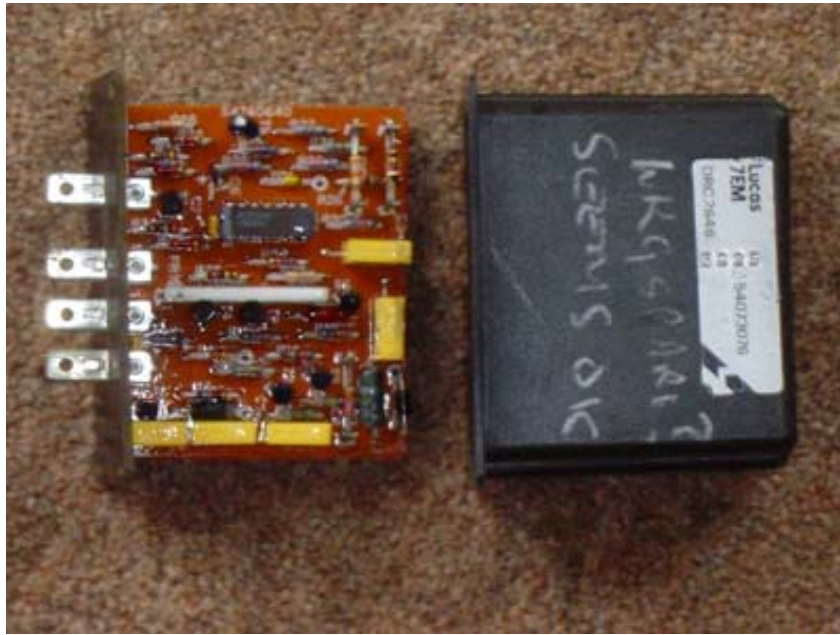
On Efi cars the normal (ex-carburettor) fuel flow meter signal to the trip computer is replaced or emulated by an interface unit (see above image) which calculates fuel usage using a signal derived from No 8 injector. Fuel usage, of course, is directly proportional to injector "open time", so electronic conversion was an obvious and accurate design solution.

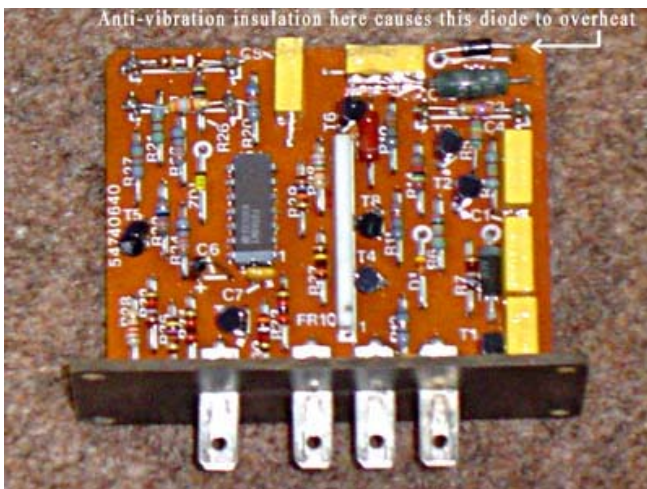
Next, I dismantled one of the units by drilling out the four rivets that secured the cover, exposing the internal printed circuit board for inspection. At the end of the board an anti-vibration foam pad glued to a large yellow capacitor also covered an adjacent diode that appeared to have overheated.

In doing so it had crystallised the adhesive, the foam and its own paint and markings leaving the diode effectively coated with carbonised junk. I cut away the offending foam, thoroughly cleaned up the diode, re-soldered all the local joints for good measure and reassembled the unit using screws in place of the rivets. Back in the car, the intermittent fault on that unit was cured.

I believe the component concerned is a Zener Diode, which is used as a reference voltage within the electronic circuitry. If true, this type of diode is known to be temperature sensitive.

On sunny days the interface location, below the windscreen, gets very hot and the combined effect of this hostile temperature and the foam pad trapping heat within the unit, with no means of cooling, causes the component to operate outside its temperature tolerance or even to fail completely. This might explain why some subsequent interfaces remained unrepairable using the above method.

- Replace the faulty diode with a higher rated device. (Without a circuit diagram or component list, I don't have a specification).
- Relocate the interface, perhaps below the fascia, but this would require a cable extension.
- Coat the diode with electrical heat sink gel/grease to further reduce the local overheating effect.
- Drill ventilation holes in the plastic cover adjacent to the diode.

So there you have it! If you own a Rover SD1 Efi car and have experienced intermittent low "Instant" mpg readings on the trip computer, as described, have a look at your fuel flow interface! My experience showed beyond doubt that the diode overheats and removing the anti-vibration insulating foam from the end of the board, cleaning up and resoldering the diode can cure the fault.
